Inspection & Maintenance Guide

Keys for Trouble-Free Operation of Wrap System

JOHN DEERE

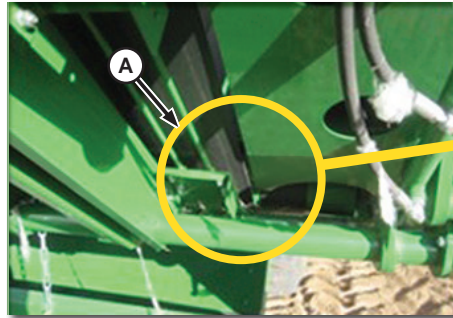
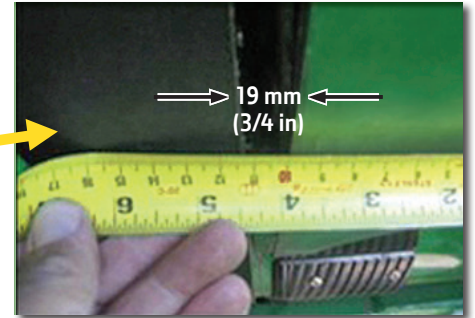
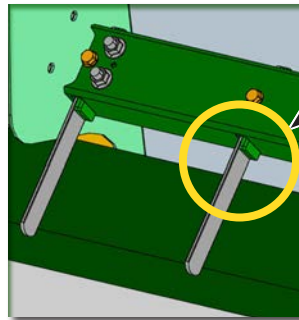
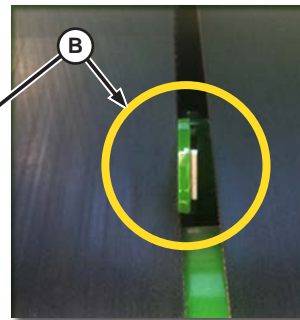
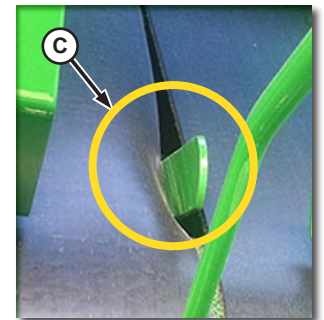
Belt Position, Tracking, and Condition

Round module builder (RMB) belt position can be inspected from the handler with the machine in harvest configuration and load-wrap mode. The outer RMB belts (A) should be positioned 19 mm (3/4 in) or less from the wall of the RMB to avoid wrap damage and to prevent cotton from carrying around the belts. It is recommended that the rear belt guides (B) be in the outermost position as shown.

Poor belt tracking occurs when belts ride up on guides and start to curl (C). If not immediately corrected, poor tracking can lead to lace damage, belt stretch, wear, or failure. For further information on checking and adjusting belt tracking, see the Round Module Builder section of the Operator's Manual.

RMB belts should be inspected daily with the machine configured in the gate in handler position. The RMB Belt Service Mode can be used to control rockshaft position and the RMB drive.

- Check belt laces for damage and pullout from belts. If any lace rivets have pulled through the belt section, replace the lace or belt.
- Check all lace pins for wear or damage. Replace pins if bent, broken, or if more than one-third of pin thickness is worn. To remove the pin, grip with pliers and rotate pin 90 degrees (1/4 turn) while applying pressure.

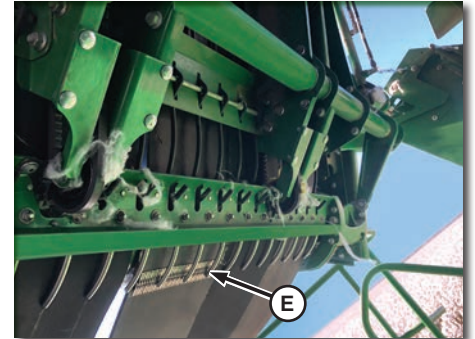
Wrap Feeding Area

Inspect wrap feeding area with machine in gate in handler position and with the gate lock valve engaged.

Steel fingers of lower rod guides (E) should not contact the baler belts or laces on the lower gate roll. Maintain 3 mm (1/8 in) to 6 mm (1/4 in) of clearance between the tip of the rods and baler belts. Rods can be manually bent to achieve proper position.

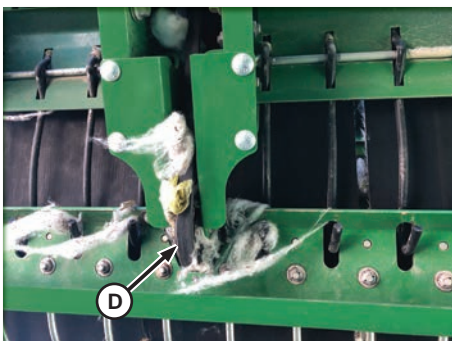
Clean Front Wrap Floor Belt Pulleys (Machine in Transport Configuration)

Clean debris (D) from all of the front pulleys during daily service.

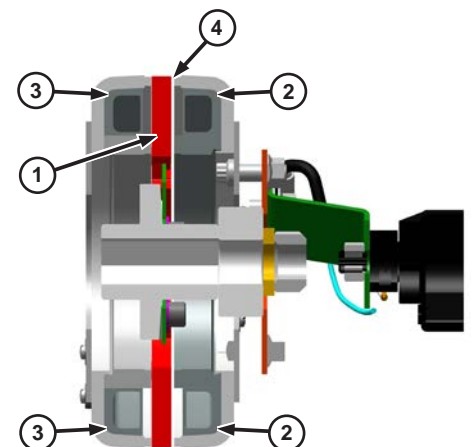
Wrap Clutch Operation

The wrap clutch controls the movement of the wrap roll by acting as a brake to hold the rollers stationary or as a clutch to engage the rollers to turn with the baler. When the brake is engaged, the coil (3) mounted to the baler structure is powered and pulls the armature plate (1) to the left. During wrap feeding, the rotating coil (2) is powered and the wrap rollers are driven with the baler.

- The air gap (4) between the armature plate (1) and the coil (3) should be consistent around the outer perimeter of the clutch.

- In load wrap mode, the bottom rubber feed roll should turn when the advance button is pushed.

- Most likely cause is that the clutch armature becomes seized and does not stop the wrap feeding when the separation tag passes the IR sensor. Refer to page 5 for information concerning the clutch.

- Proper Z-lock separation relies on quick response of the clutch to stop feeding the wrap when the separation label is seen. This is accomplished by the armature plate shifting from the pulley-mounted coil to the fixed coil. If the armature plate does not slide freely, separation is delayed and some of the next wrap portion may be fed into the chamber. Contact your John Deere dealer for service.

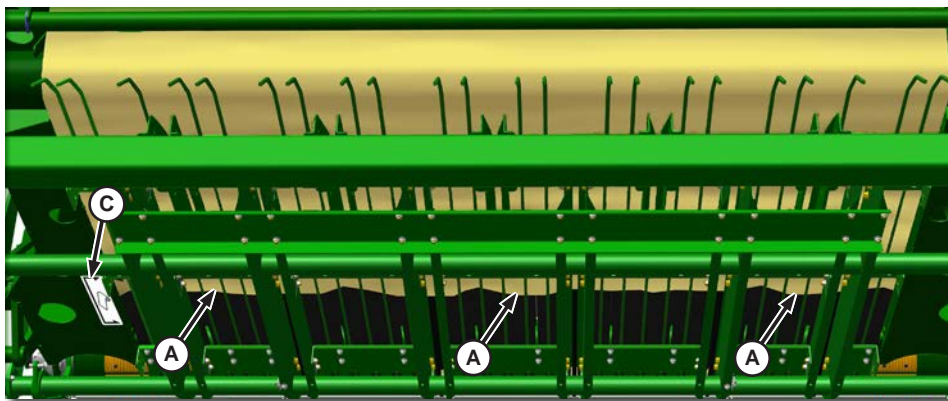
Wrap Leading Edge

After cleaning or transporting machine, ensure that the leading edge (A) of the wrap is properly positioned and not caught on a rod or pushed up between the belts above wrap floor (as shown in photo at location B).

Also ensure that debris has not accumulated on top of the wrap leader during cleaning.

A pictorial label (C) on the machine frame shows the proper position of the leading edge of the wrap.

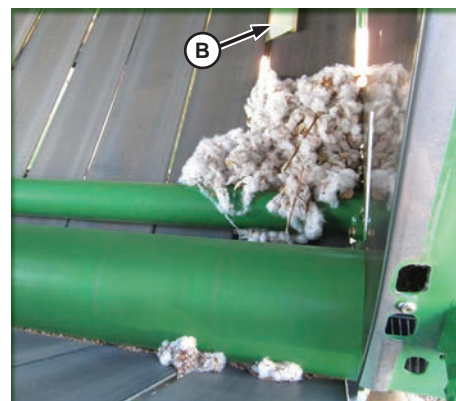
Verify that there is no cotton on top of the belts in the gate chamber (as shown).

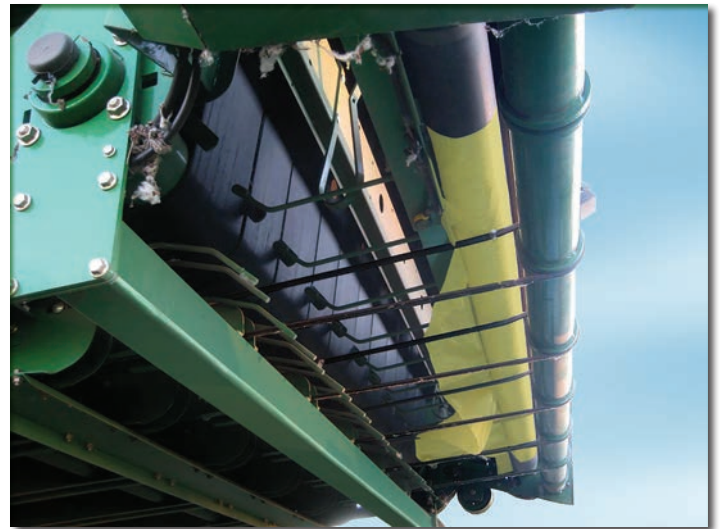
Wrapped Rubber Roller

If rear wrap rollers are turning, the machine assumes that wrap is feeding in and calculates the amount fed in based on the speed signal. Once a calculated amount of approximately 2.5 m (8 ft 2-7/16 in) is fed in, the wrap floor retracts. If the leading edge of the portion has not entered the chamber by this time, it will likely not feed in and result in accumulation on the wrap floor. This allows the rear roller to "grab" it and roll it up.

When removing wrapped material from the bottom roller, pay attention to which material is closest to the rubber: non-tacky or tacky.

Non-tacky next to rubber

This suggests that the leading edge may not have fed into the chamber, bunching up on the wrap floor belts until the rubber roll grabbed it and pulled the bunched up material backward onto the roll.

- Obstruction at the lower gate roller. Wrap could not enter the chamber.
- Adhesive deposit on the rubber roller. Remove roller and inspect. Clean with acetone if deposits are found, using appropriate personal protective equipment. If acetone is not available, "neutralize" with dust/dirt until it can be cleaned later.
- Wrap core is tight between wrap supports. Wrap does not feed into bale chamber before the wrap floor retracts. If a tight core is found, cut the end of the core to allow the core to turn freely.

This suggests that the non-tacky section fed in, and there was a failure in the tacky section that caused it to break in two during feeding.

- Joint between the non-tacky section and the tacky section failed.
- Crosswise tear during feeding. Potential material issue. Report to your John Deere dealer.

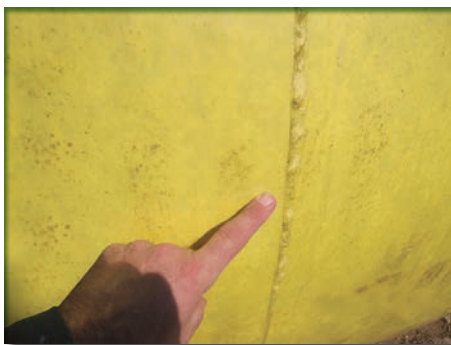
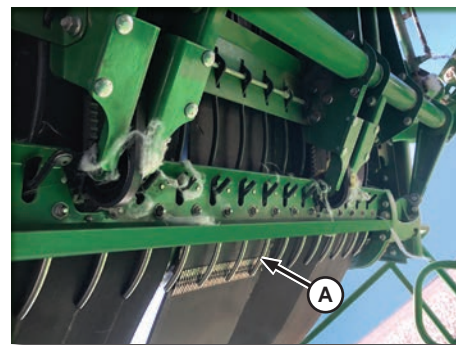
Intermittent Damage to the Tacky Wrap

- Bent finger on the lower guide rod is contacting the baler belt. There should be 3 mm (1/8 in) to 6 mm (1/4 in) of clearance between fingers (A) and the baler belts. The easiest way to check is in the RMB Service Setup Mode with the gate in cradle.
- **Hint:** Notice that the spacing between the tears is equal to the spacing between the fingers. This can help determine the source of the damage.

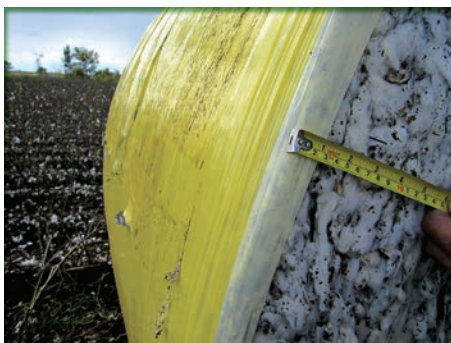
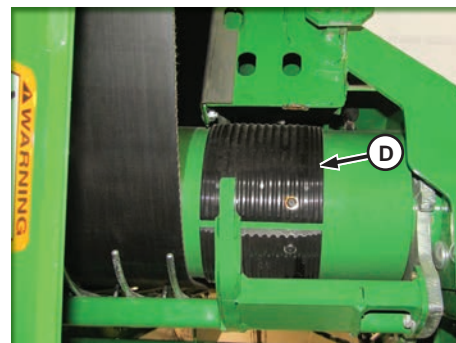
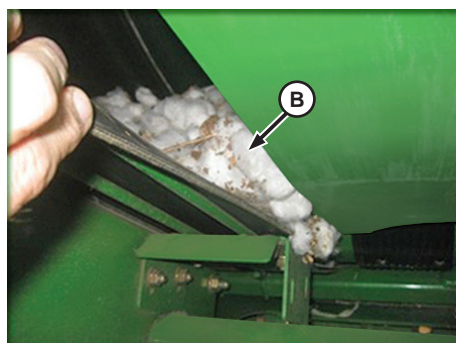
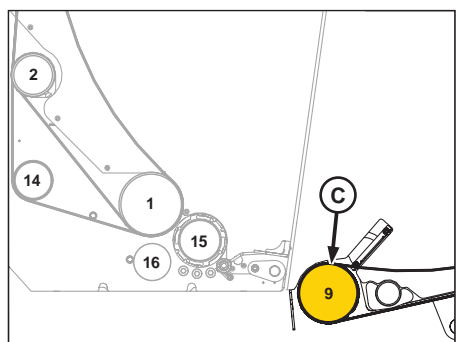
Inadequate or No Cover-Edge

- Cotton buildup (B) inside the baler belts behind the lower gate roller (C). This is often the result of excessive gap between the side wall and outer belt. Refer to page 4 for inspection and adjustment.
- Debris in wrap feeding area. Verify that wrap floor and fingers are clean.
- Improper gate position. Verify that turnbuckles at the top of the baler are set correctly and that the lock nuts are tight.
- Wear of plastic guides (D) on the lower gate roller (C). Replace guides if worn.

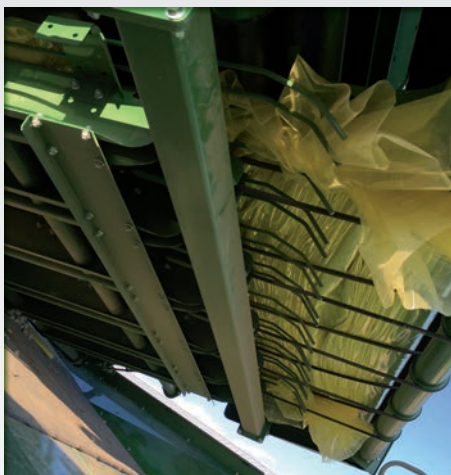
Wrap Bunching on Floor

Machines equipped with grooved lower roller and fingers.

- Leading edge of wrap did not feed into the chamber, resulting in accumulation on wrap floor.
- Check for obstruction at lower gate roller.
- Verify that wrap feeding area components (guide rods) are set correctly. Bend rods as necessary to maintain 3 mm (1/8 in) to 6 mm (1/4 in) clearance between the tip of the rods and the baler belts.

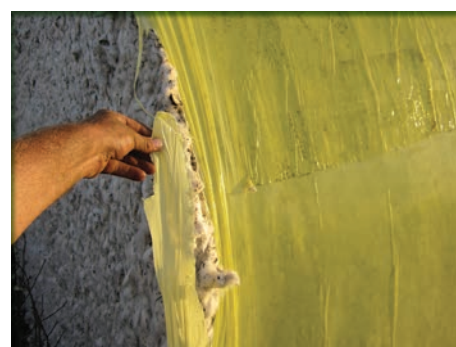
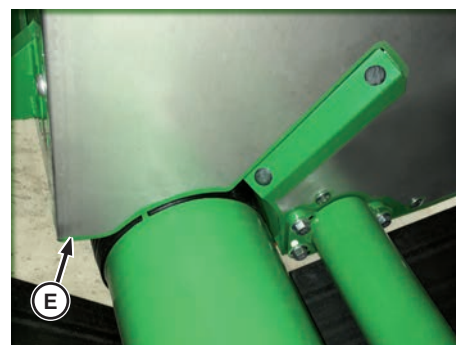
Edge Tear

- Excessive gap between outer belts and RMB wall. Adjust gap as described on page 4 of this guide.
- Damage to baler interior side sheet (E). Stainless steel panel should be smooth and free of dents or bends.

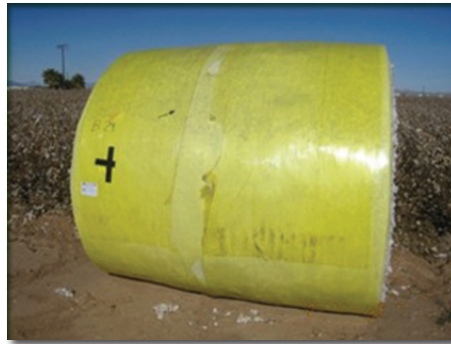
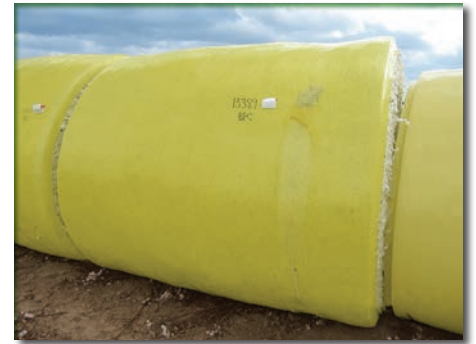
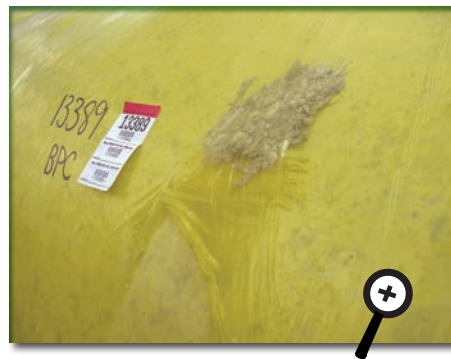
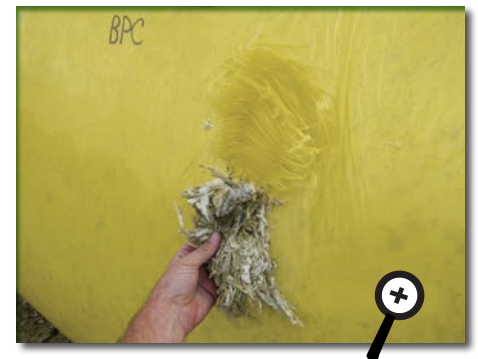
Wrap Torn Dramatically

- A damaged or twisted belt in the baler. Inspect bale chamber.
- The photos to the right show the result of a "wad" of cotton getting lodged in the lower guide rod during wrap feeding and eventually feeding in with the wrap. This wad of cotton likely ended up on the wrap floor after cleaning the machine. A good practice after cleaning the machine is to verify that the wrap floor and the leader of the next wrap portion are free of debris.

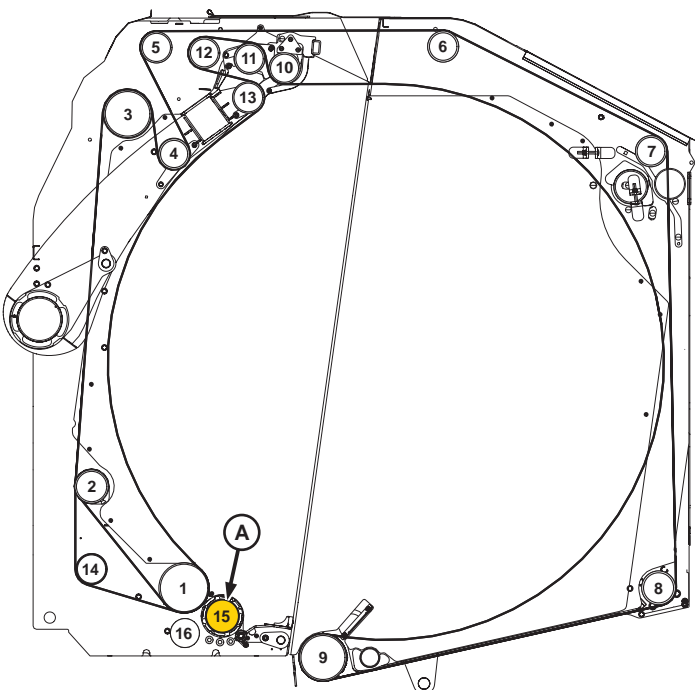
Unwrapped Module Ejected - Wrapping of the Starter Roll

- Wrap feeds into the chamber, but it wraps around the starter roll (roll 15 shown below in yellow) and winds up on it instead of wrapping around the module.

- Bunching of the wrap or uneven feeding increases the chance of this happening. Inspect the wrap floor for debris or incorrect guide rod clearance.

NOTE: A good practice is to do a quick visual check of the wrap slot via the remote camera before ejecting the module. If wrap is not observed in the wrap slot after wrap feeding process is complete, this indicates that the wrap has gone around the starter roll.

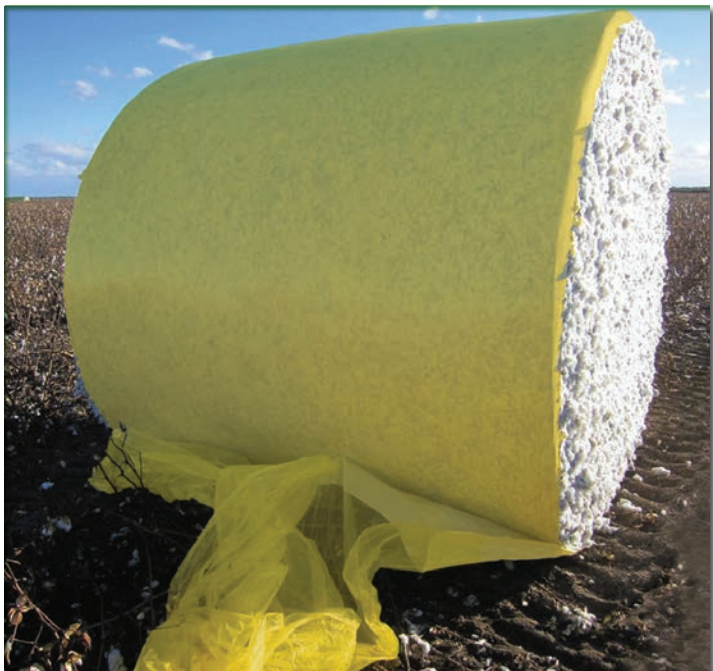
Partially Wrapped Module or Wrap Trailing out of Gate after Ejection

- Wrap does not separate and pulls in another portion. Upon ejection, when the round module rolls down the ramp, it unrolls the wrap that is on the module.

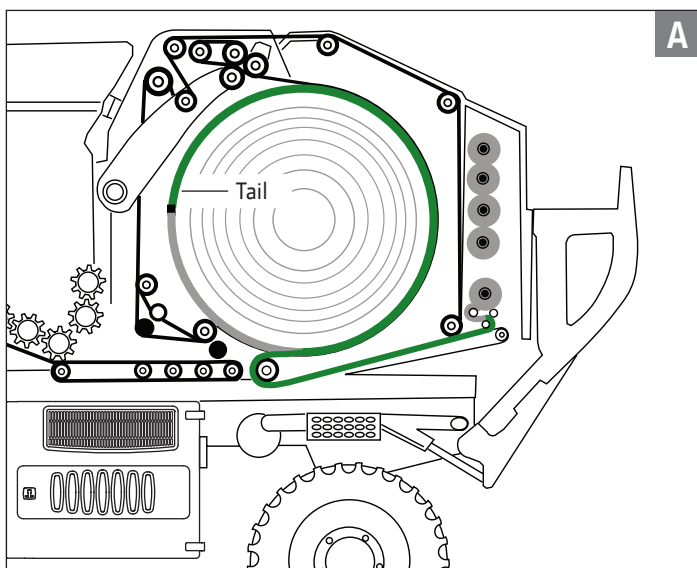
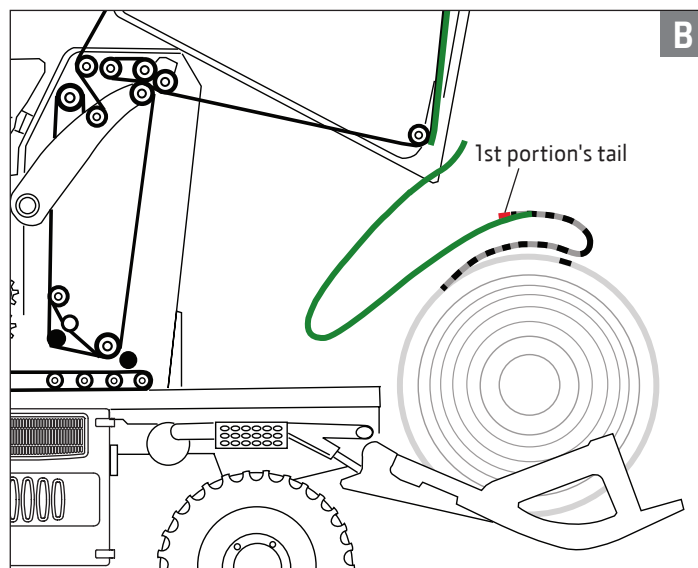
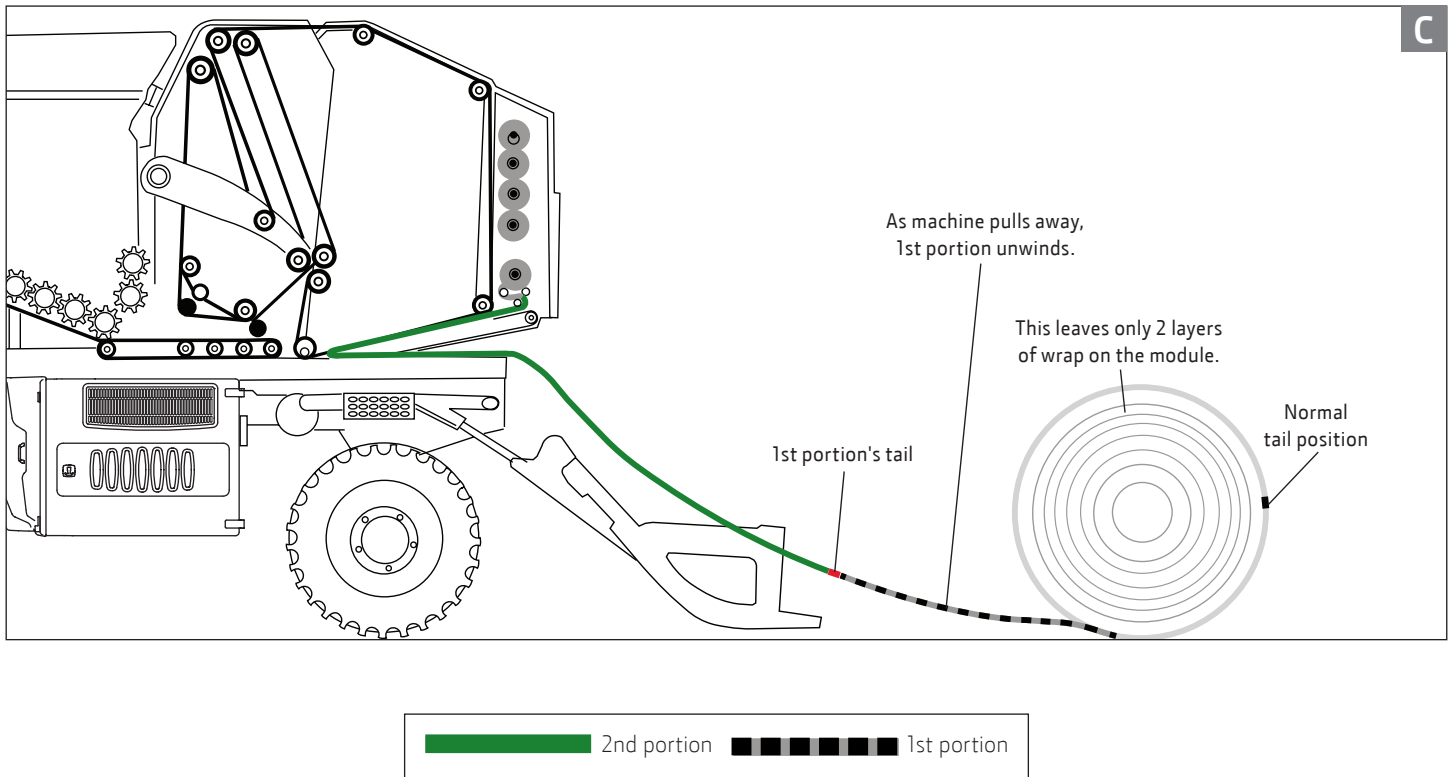
- After Z-lock separation, the baler rotates the module in the chamber in order to get correct tail orientation after the module is ejected. This means that the tail is towards the front side of the module (nearest the cab) before it is ejected (see figure A). If Z-lock separation does not occur, the baler will pull in approximately 5 m (15 ft) of the next portion. When the module is ejected, it rotates approximately 180° from its position in the chamber to its position on the ground. As the module rolls down the ramp and handler, it unwinds the 5 m (15 ft), and continues to unwind the tacky section of the first portion (see figures B and C).

Potential risk: Loose tails can cause contamination of material.

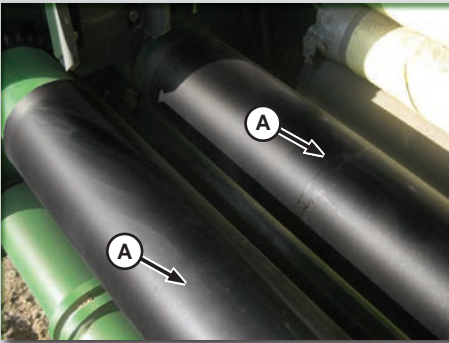
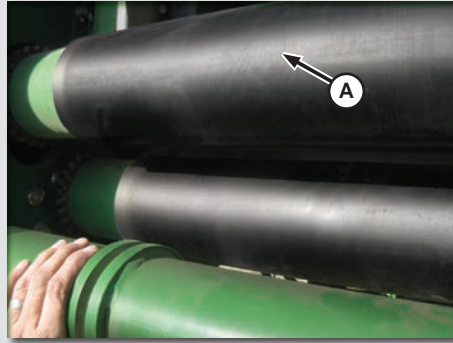
Adhesive Deposit on the Rubber Rollers

- Possible adhesive from the separation label or RFID label (A).
- Adhesive from the tail.

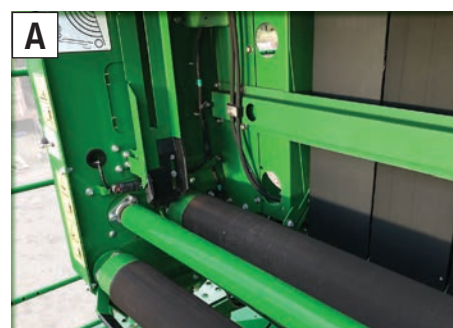
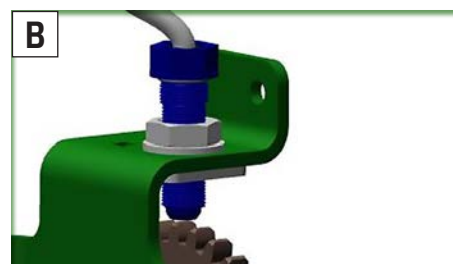
- Separation label not present or comes off and adheres to the wrap rolls.
 - If found on roller (figure A), remove and clean with acetone, utilizing appropriate personal protective equipment (PPE).

- Verify wrap roll speed from the monitor in the cab. Correct speed is 233 rpm during wrapping and 100 rpm toward the end of the cycle for separation. If speeds are incorrect or erratic, verify that the gap between the sensor and gear tooth is 1.5 mm (3/32 in). The sensor (figure B) is on the right-hand side of the wrap box.

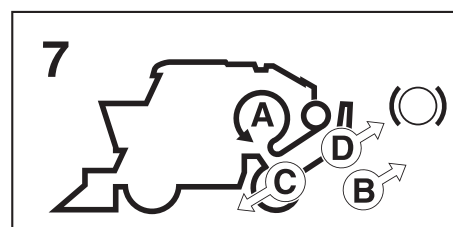
Manual Wrap Mode Instructions

- You know that you are getting toward the end of the wrap when the bright yellow tacky strip appears. You can hear noise when the tacky strip begins to unroll.
- The Z-lock is the temporary connection between the bright yellow tacky strip and the non-tacky section, which is the beginning of the next portion.

- Push button D. This applies the clutch brake to separate the Z-lock.
- Push button A and hold for approximately 7 seconds. This orients the module similarly to AUTO mode.
- Put the machine in the Manual Eject mode by pressing button 3 on either keypad.
- Manually eject the module using the tether control.

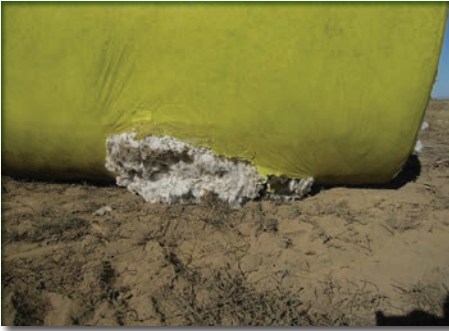
Handling Damage to Wrap

- Turning tractor before forks pulled away from module.

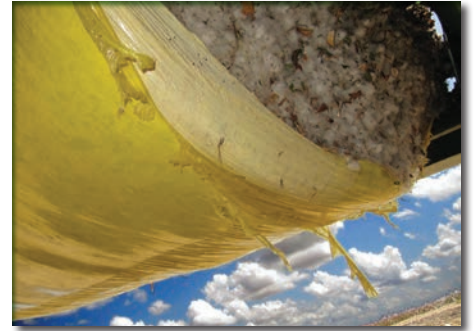
- Turning machine or raising handler before handler is away from module.

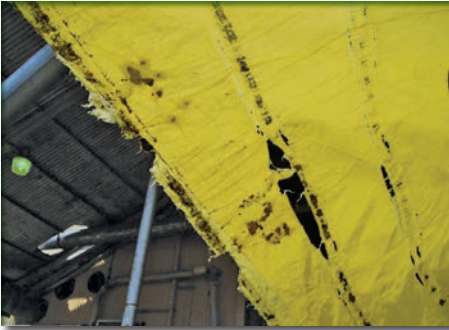
- Bottom drag on the stalks.

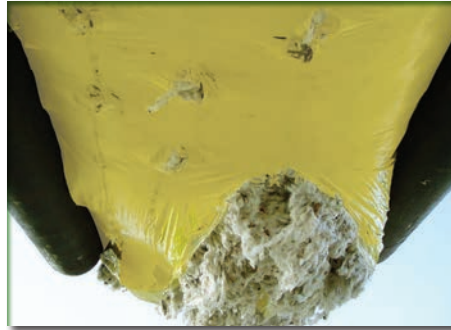
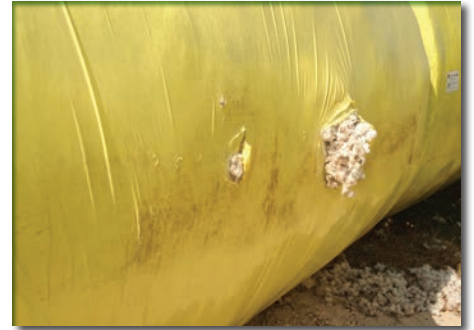
- Damage if inappropriate chains are used (see figures below) or if chains are run after load reaches front of truck.

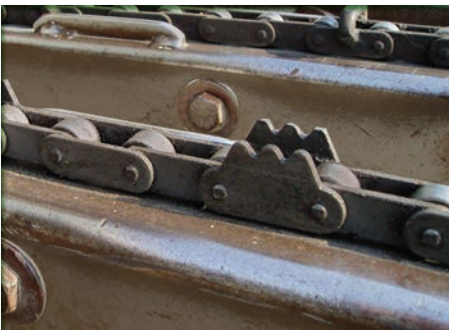
- Damage from the module truck side wall during load/unload.

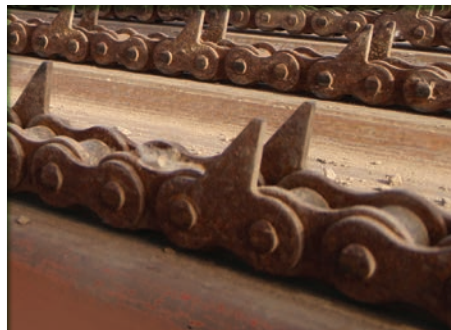
- High potential to damage wrap.

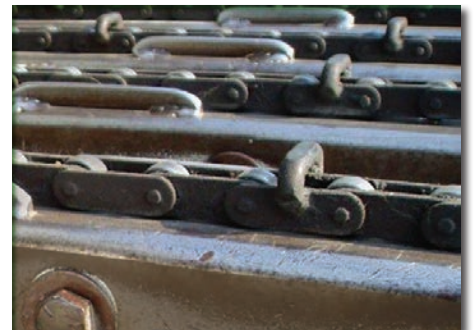
- High potential to damage wrap.

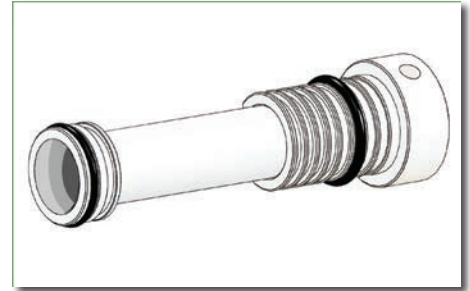
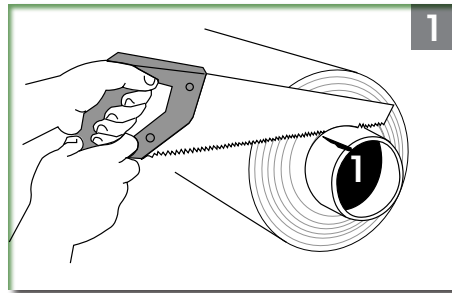
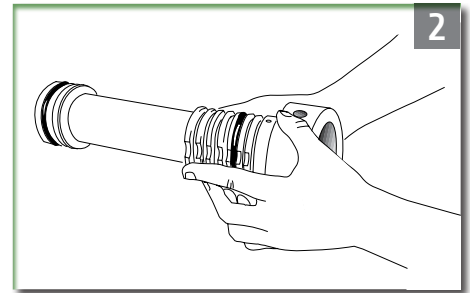
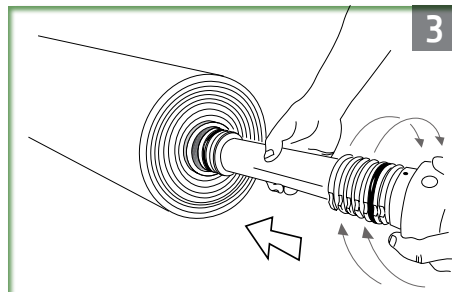
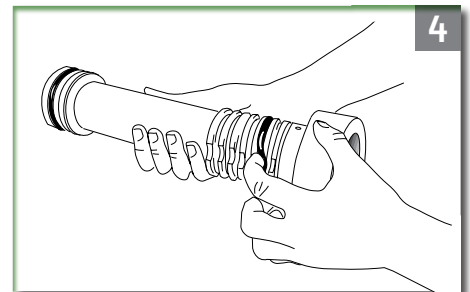
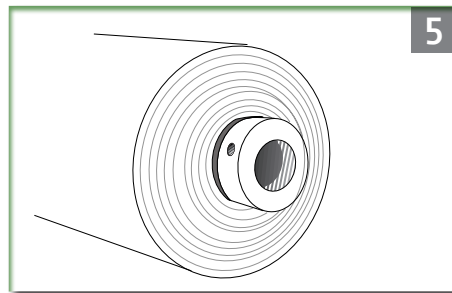
Wrap Roll Core Repair

The core repair extension is a tapered plug that can be inserted into the original core of the wrap roll to replace a cracked or damaged core end. The extension has a set of 7—8 grooves that are graduated in diameter, from narrowest to widest. A pair of rubber O-rings are supplied in the kit. Use both the wide black O-ring and the narrow black O-ring as described below.

1. Cut off the damaged end of the core carefully (figure 1), making sure not to damage the roll of material. Refer to step 6 for maximum core length.
2. On the repair extension, slide the wide black O-ring onto the sixth groove in the external grooved section. The narrow black O-ring supplied in the kit should be placed on the short grooved section located in the internal side of the flange (figure 2).
3. Insert the repair extension into the core in spiral motion (figure 3). There should be a slight resistance when inserting the extension.

4. If the repair extension is too loose, move the O-ring to a wider groove (figure 4) and repeat step 3. Moving the O-ring closer to a wider groove increases the resistance.
5. The extension should firmly grip the core (figure 5).
6. With core repair extension inserted, measure the overall length of the core by inserting a tape measure through the inside of the core (figure 6). Overall length should meet specification: 2790—2784 mm (109-13/16 in—109-5/8 in).

NOTE: Core must not exceed maximum length or roll will not install properly.

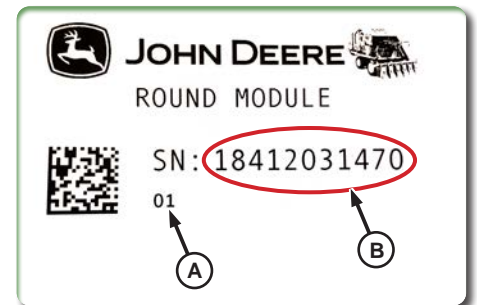
- Portion number (A)
- Unique RM Serial Number (circled in red) (B)
- Year of manufacture (first two digits of RM serial number)

When reporting an issue, ensure that both serial and portion numbers are included.

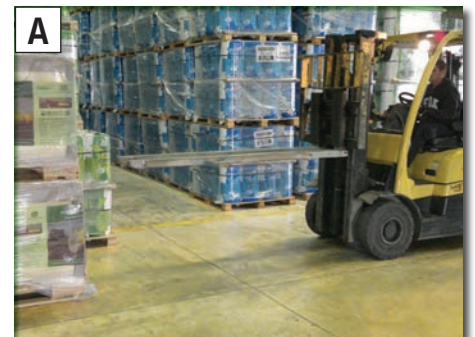
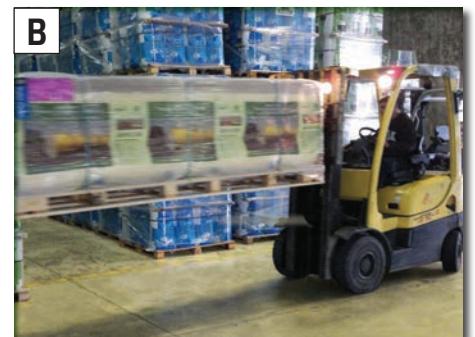
- Handle ONE pallet at a time.
- To handle the pallets, use a suitable forklift. The recommended lift capacity is 2000 kg (4400 lb).
- Use long forks and handle pallets from the narrow end to minimize damage (figures A and B).
- USE PALLET PULLER when unloading from truck.
- Pallet pullers are available from material handling supply distributors.

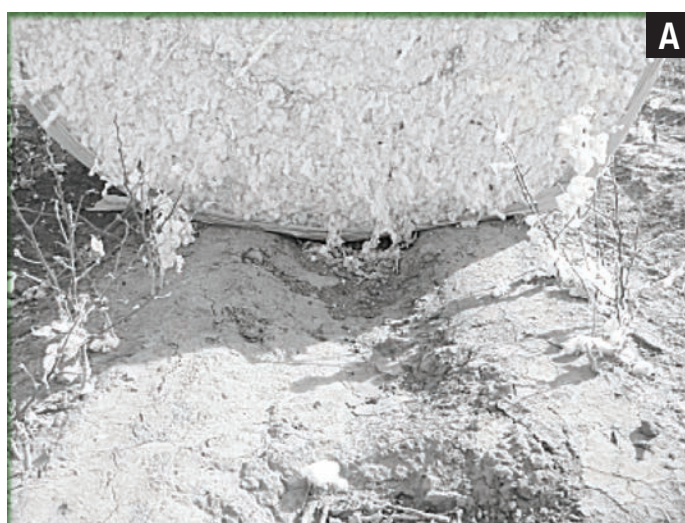
Incorrect Staging Surface

- Modules should be staged on a high flat surface. Staging on well-defined flat driveways or a flat disked surface is optimal.
- When choosing a staging location, ask yourself if a module truck can retrieve from this location after a significant amount of rain.
- If a module truck tire and/or tracks slip while gathering the load, damage may occur to the underside of the module due to the relative chain slip.
- If at all possible, do not stage modules on top of rows or beds or in internal portion of field where module truck access is difficult. Modules take the shape of the surface they are placed on (see figure A). Setting on beds or uneven surface requires digging into the ground with the module truck chain to safely get under the entire surface of the module.

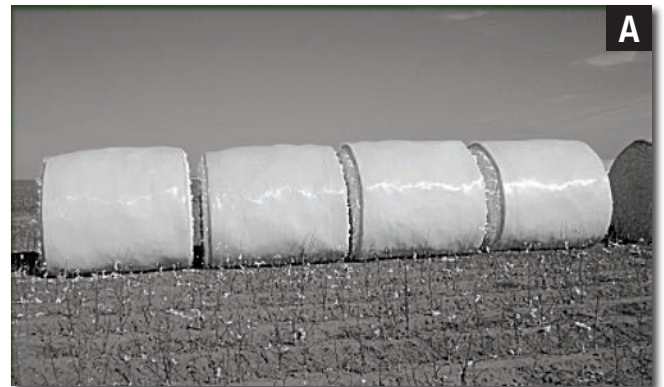
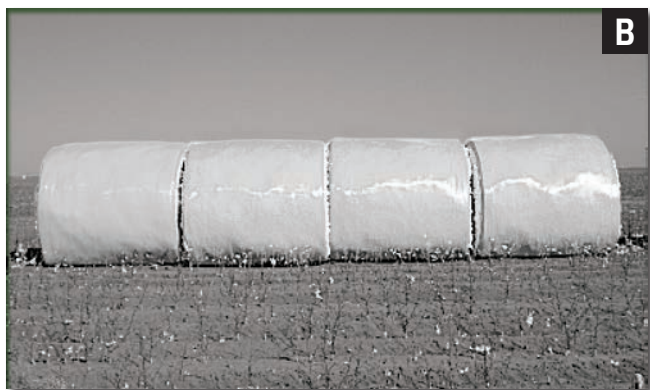
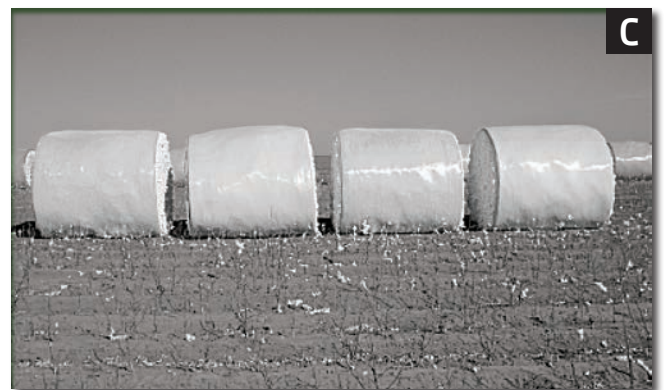
Gaps that are too small (see figure B) can cause tearing as modules travel up module truck incline due to interference with adjacent modules. Also, having module ends contacting each other during long-term storage can increase chances of mold growth. Gaps between modules allow ventilation.

Gaps that are too large (see figure C) can cause four modules to be too long for the available truck bed length.

A—Proper Center Alignment B—Improper Center Alignment

Improper alignment increases the chance of wrap tear due to the truck driver having to stop and start loading procedure and from the modules rubbing the trailer walls.

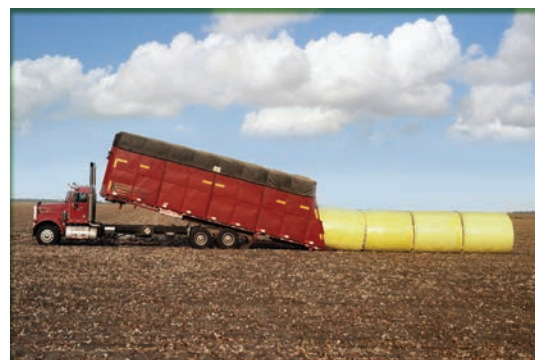
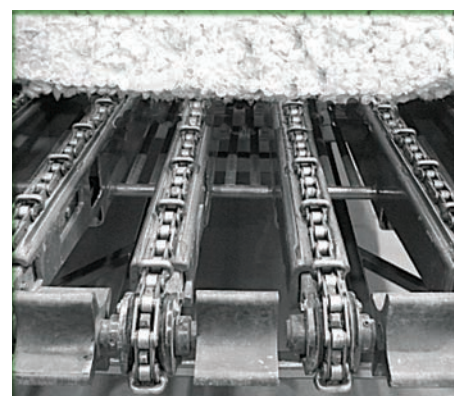
Preferred Chain

- Module trucks with 12-bed chains must have inside eight chains replaced with the Stover RMS chain to prevent damage to the module plastic wrap.
- Module trucks with 11-bed chains must have inside seven chains replaced with the Stover RMS chain to prevent damage to the module plastic wrap.

- As a final check, non-Stover RMS chain is only allowed within 43 cm (17 in) of module truck inside wall surfaces.
- If chain tail wheels are sprocket-style, paddle-style with sharp points, or narrower than 5 cm (2 in), replace with the wide and smooth paddle-style tail wheels.

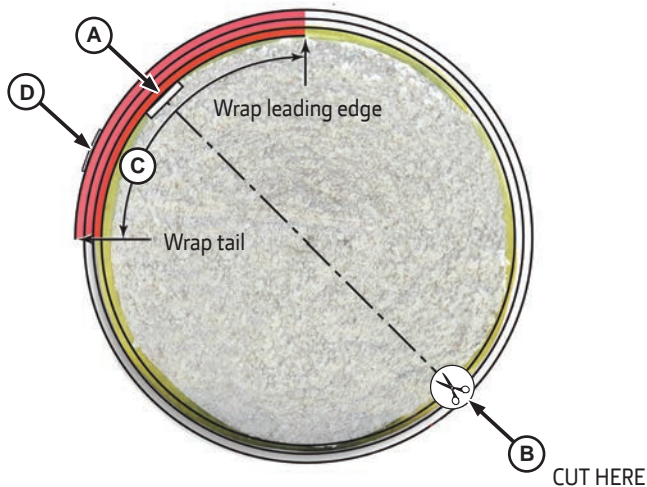
NOTE: The red zone (C) is a "No Cut Zone". Cutting in this area may cause small pieces of wrap to enter into the cotton.

A—RFID Tag
B—Safe Cutting Zone

C—Wrap Tail and Leading-Edge
Overlap (NO CUT ZONE)
D—White Metallic Label

- 1) The wrap cutting location must be opposite the inner tail to eliminate the potential of cutting through the tail. An RFID tag is placed at the inner tail for locating.

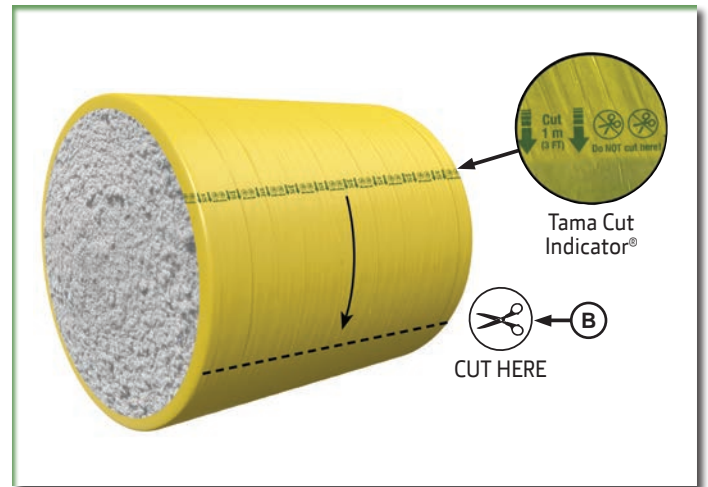
The safe cutting zone is 1 m (approximately 3 ft) from the Tama Cut Indicator®, measured in the direction of the arrows that appear on the Tama Cut Indicator®.
